TECHNICAL REPORT GL-86-7

SEISMIC STABILITY EVALUATION OF ALBEN BARKLEY LOCK AND DAM PROJECT

Volume 5 STABILITY EVALUATION OF GEOTECHNICAL STRUCTURES

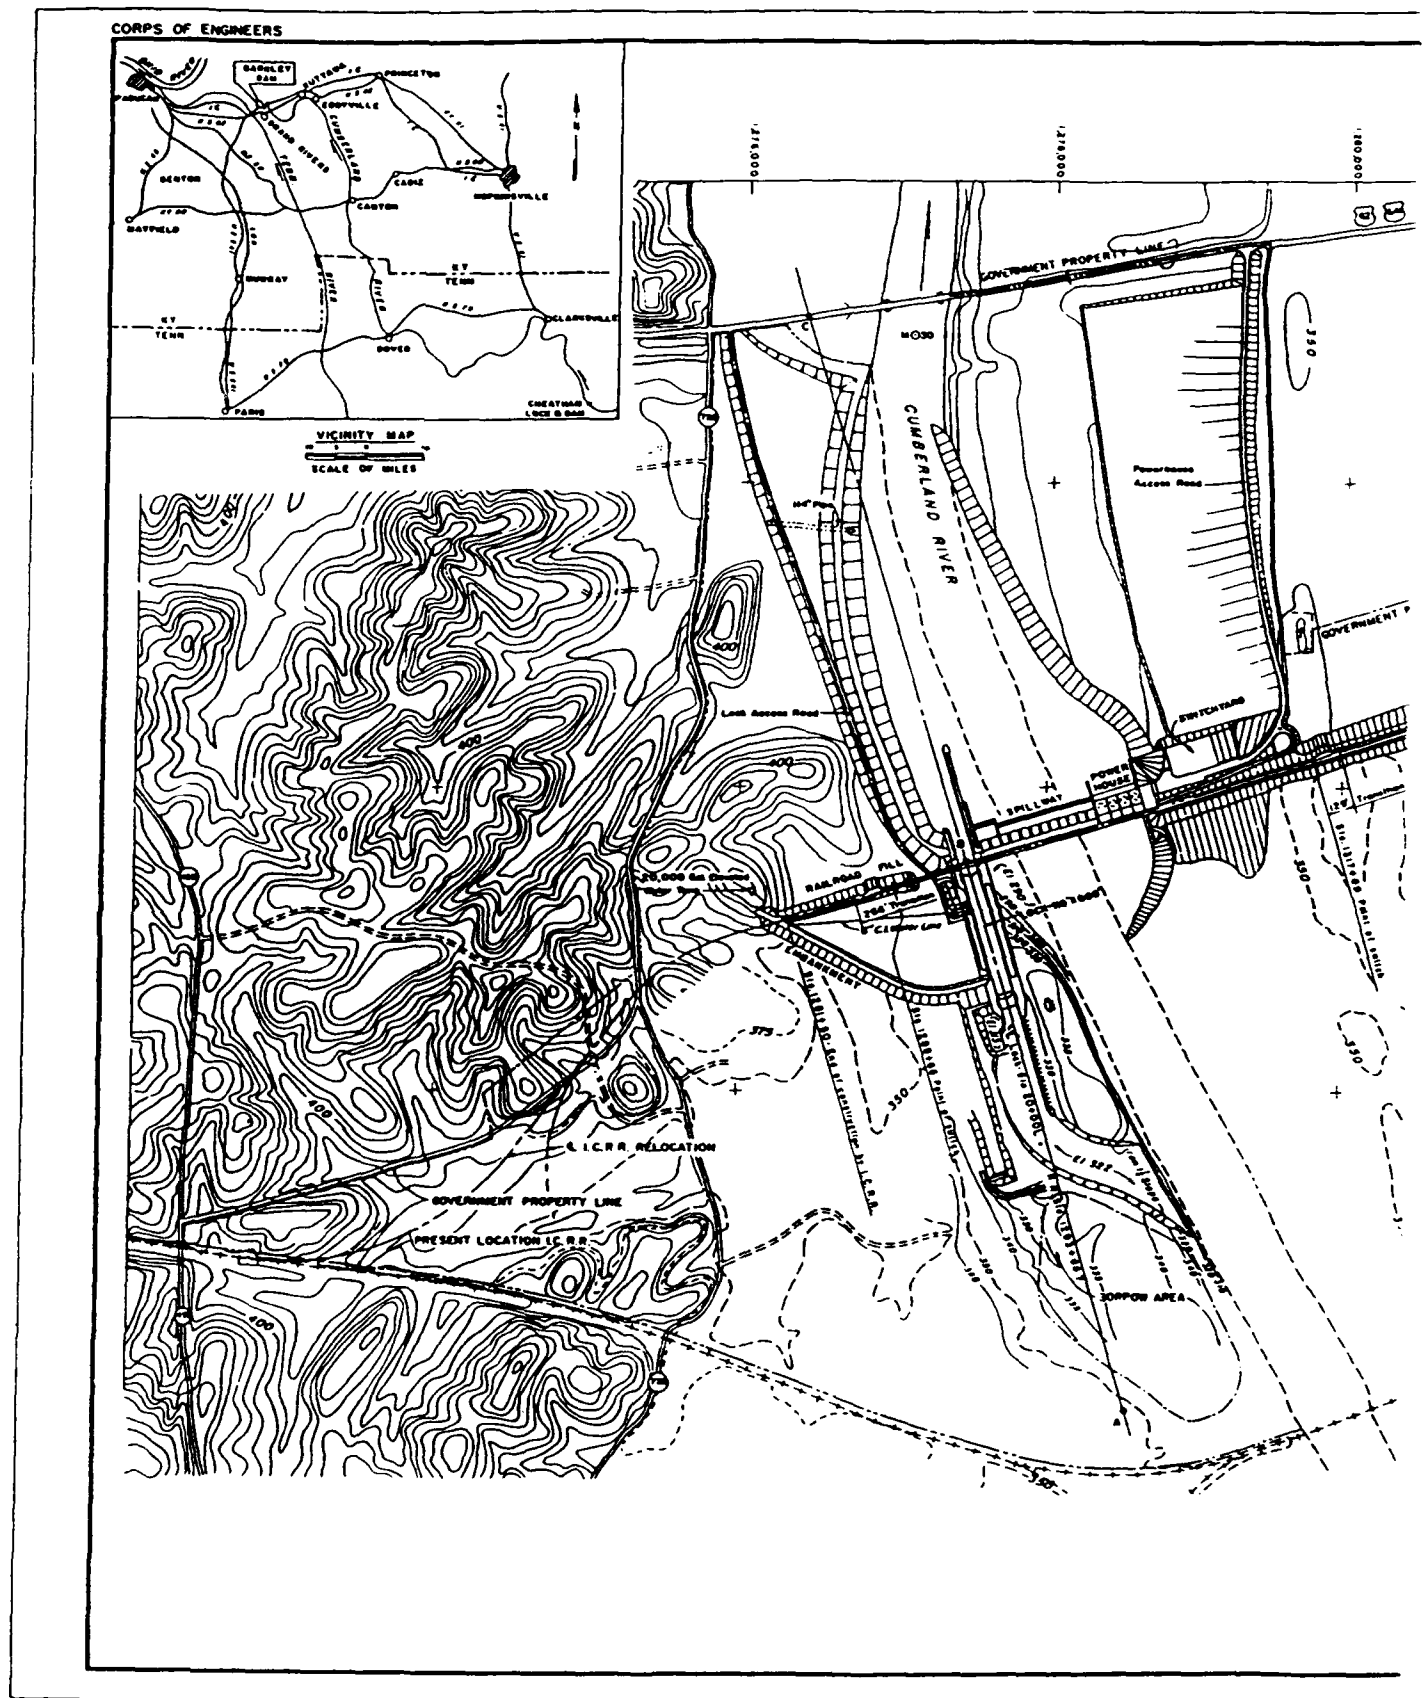
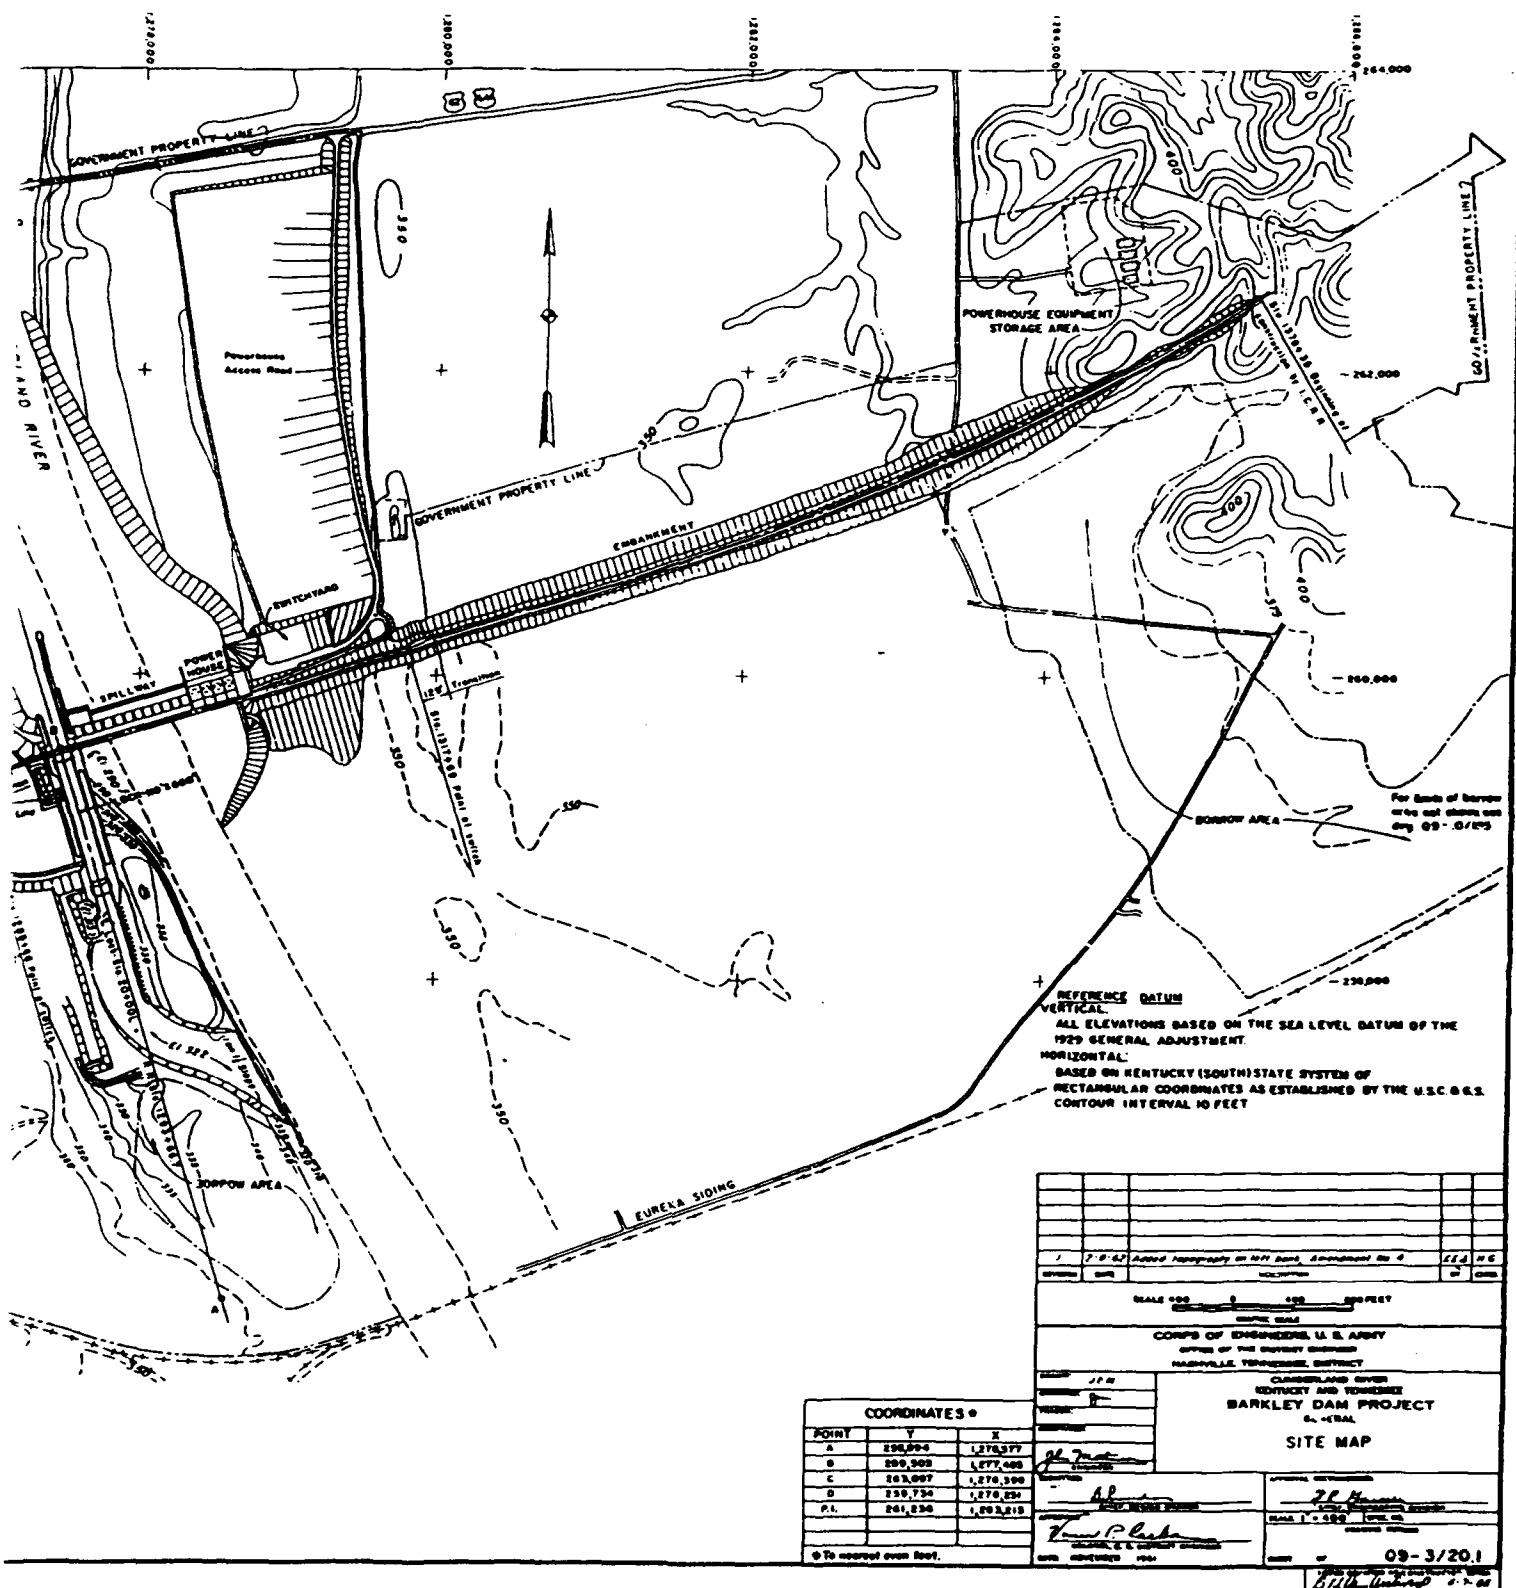
Figure 1. Plan view of the Barkley Lake

view of the Barkley Lake and Dam Project.

2. Construction of the Barkley Project began in 1957 and was completed in 1966. As a key unit in the comprehensive plan of development of the Cumberland River, the multi-purpose Barkley Project provides flood control, hydroelectric power, navigation, and recreation. The reservoir is contained by a concrete gravity section flanked by earth embankment dams. The concrete gravity dam, powerhouse and lock system is 109 feet tall at maximum section. The embankment dams are founded on an alluvial deposit with a maximum thickness of approximately 120 feet. The alluvial deposit is underlain by Mississippian limestone. The alluvium, a complex layering of clays, silts, sands, and gravels, is the focus of concern in the seismic safety assessment due to the possibility of liquefaction of these sediments during an earthquake. The dam supports a railroad track system which traverses most of the dam crest. A canal, large enough for barge traffic, connects Barkley and Kentucky Lakes about 2.5 miles upstream from the dam. At the maximum flood control pool, elevation 375 feet, the reservoir stores 2,082,000 acre-feet, with 13 feet of freeboard (minimum crest elevation 388 feet). For normal operation, the pool elevation varies from 354 to 359 feet, and stored volume varies from 610,000 to 869,000 acre-feet, respectively. A pool elevation of 360 feet was used for the seismic stability evaluation. A location map and plan of the project are shown in Figure 1.

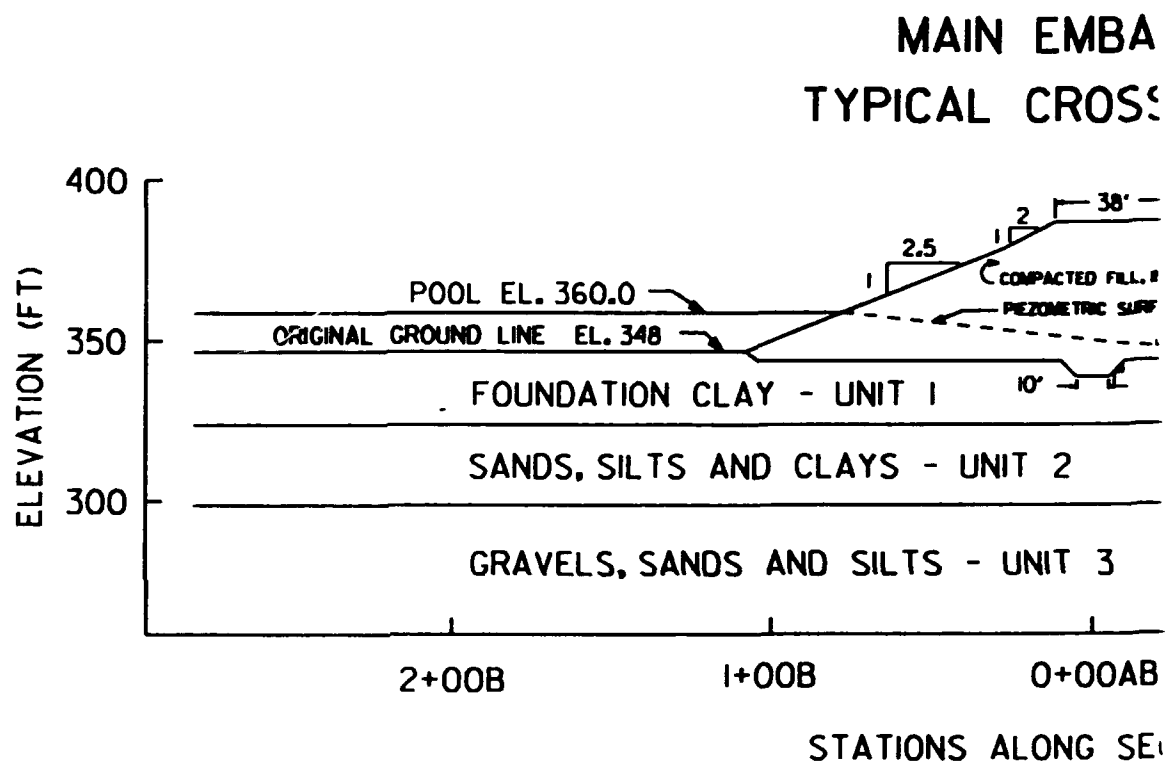
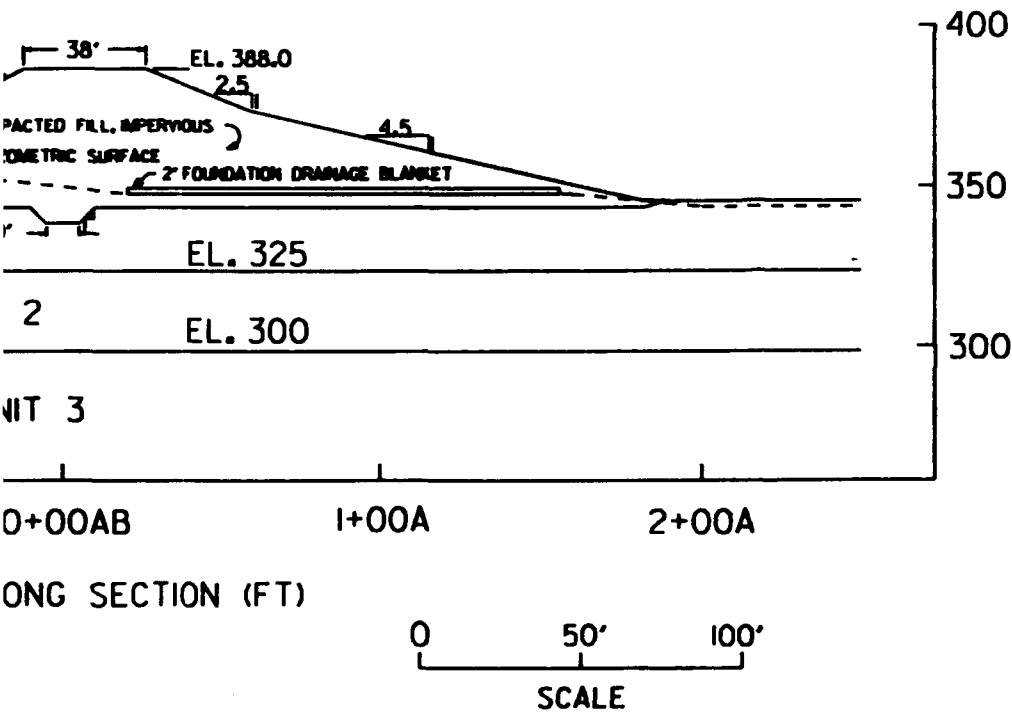
Figure 2. Main embankment - t

EMBANKMENT CROSS SECTION

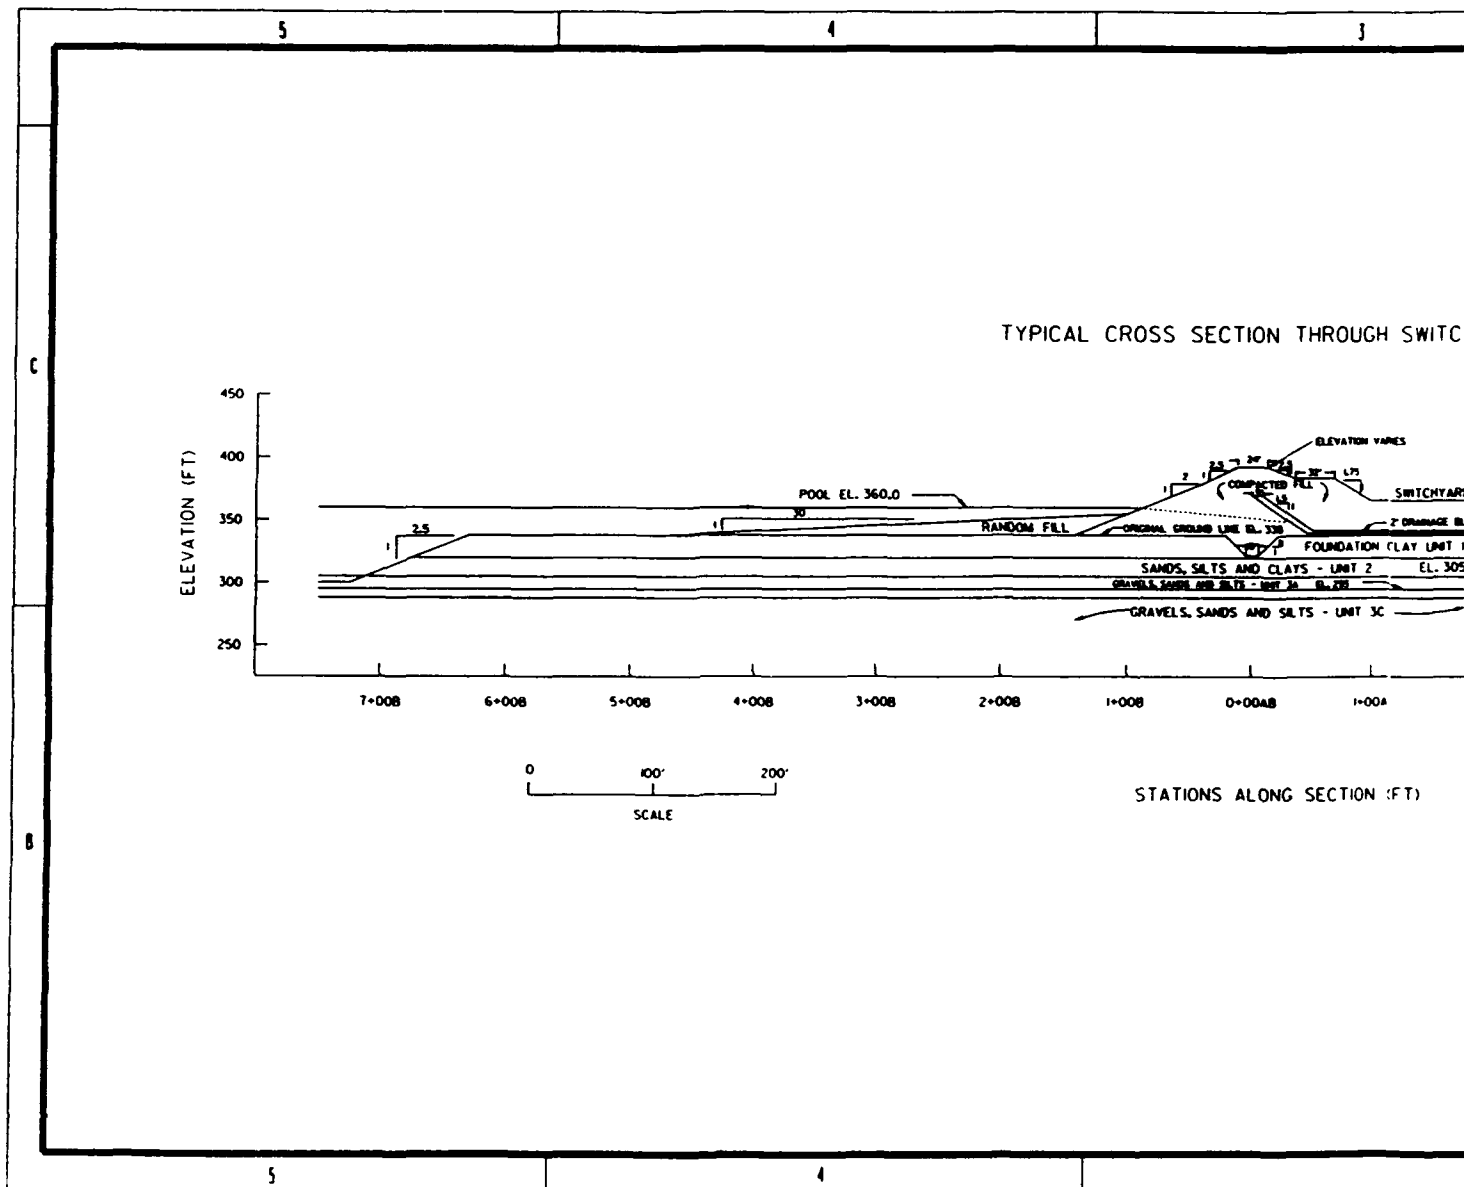
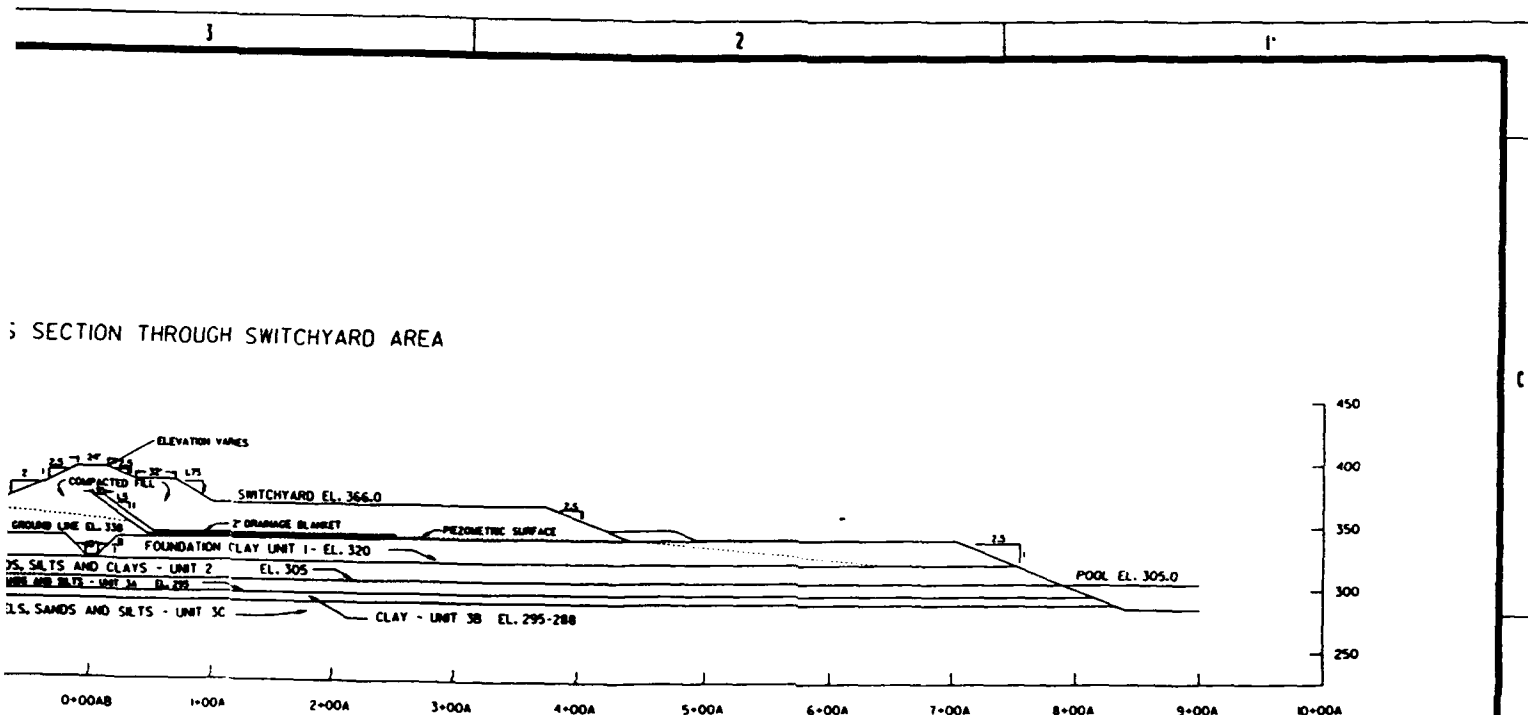
Figure 3. Typical cross sec

SECTION THROUGH SWITCHYARD AREA

ypical cross section in switchyard area.

9. Stability analyses were performed on two sections of the dam, one for the main embankment and the other through the switchyard. A plan view showing the location of these sections is shown in Figure 6 and typical cross sections through the main embankment and switchyard are shown on Figures 2 and 3, respectively. Circular failures were assumed for the section through the main embankment. Geometry of the dam and foundation dictated that circular failures be assumed because the free field beyond the toe of the dam extends for a large distance and Unit 2 does not daylight as it does in the switchyard area. Critical wedge failure surfaces approximate a circular surface and therefore were not used. In the switchyard section a wedge type failure is assumed to occur, exiting into the tailrace channel. This section is curved section in plan, cutting through the embankment and curving toward the tailrace channel.

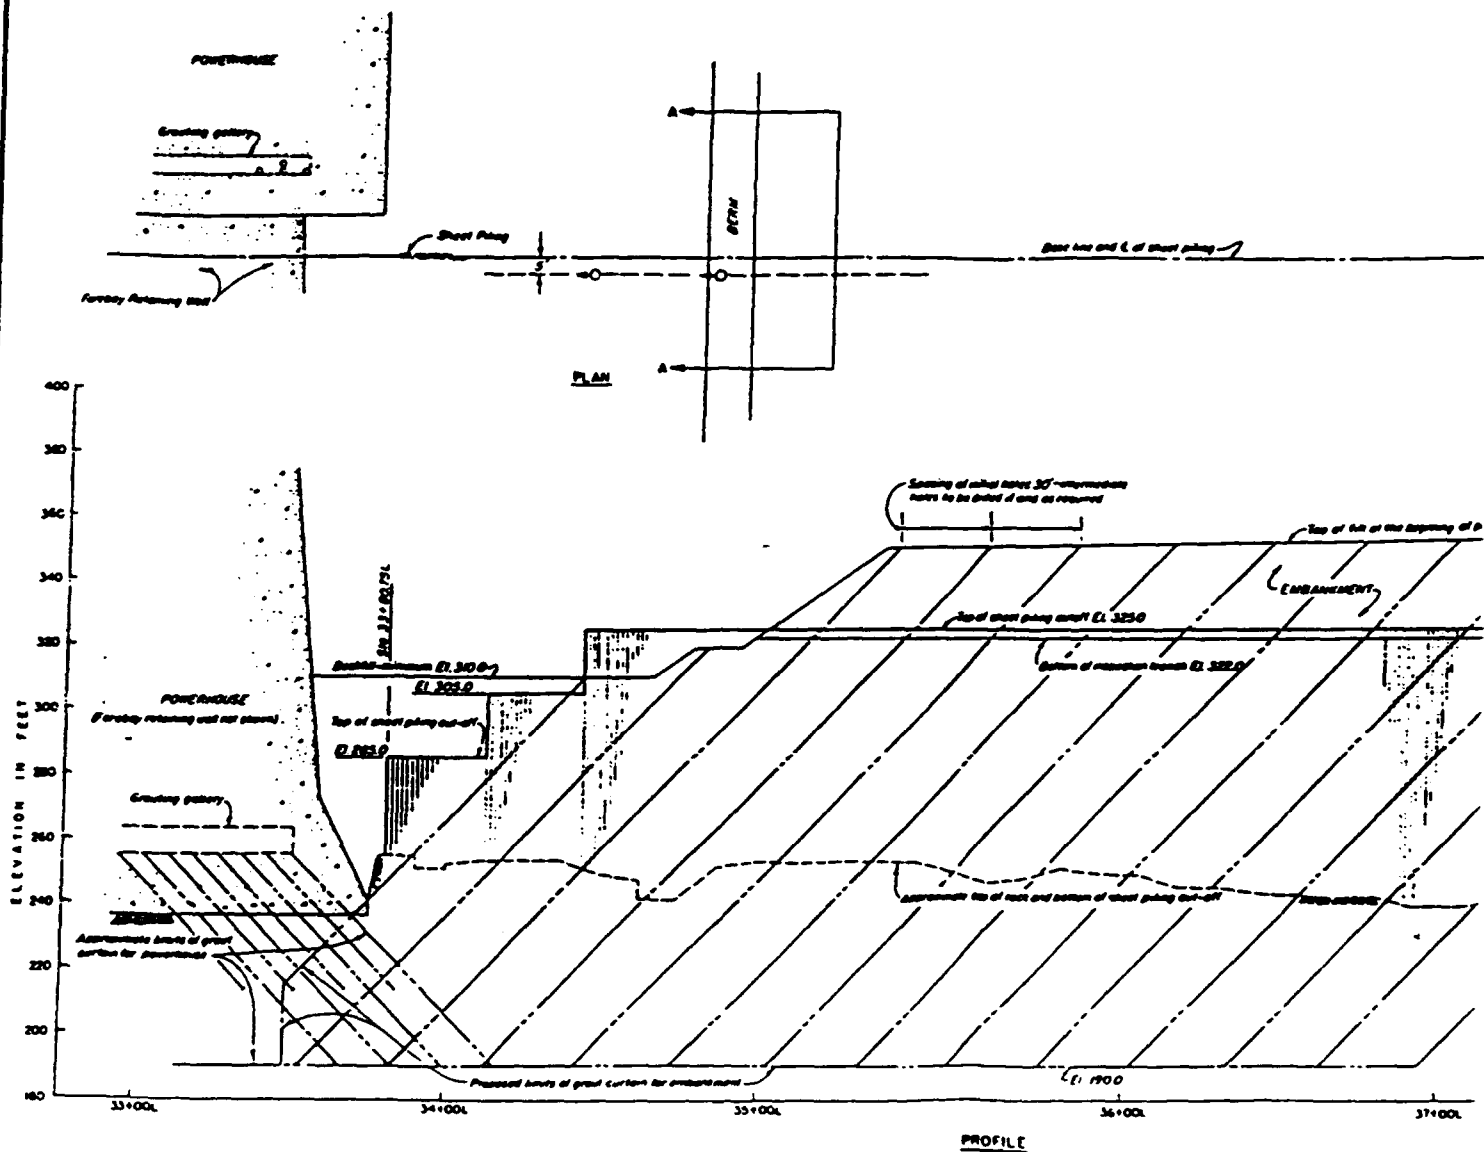
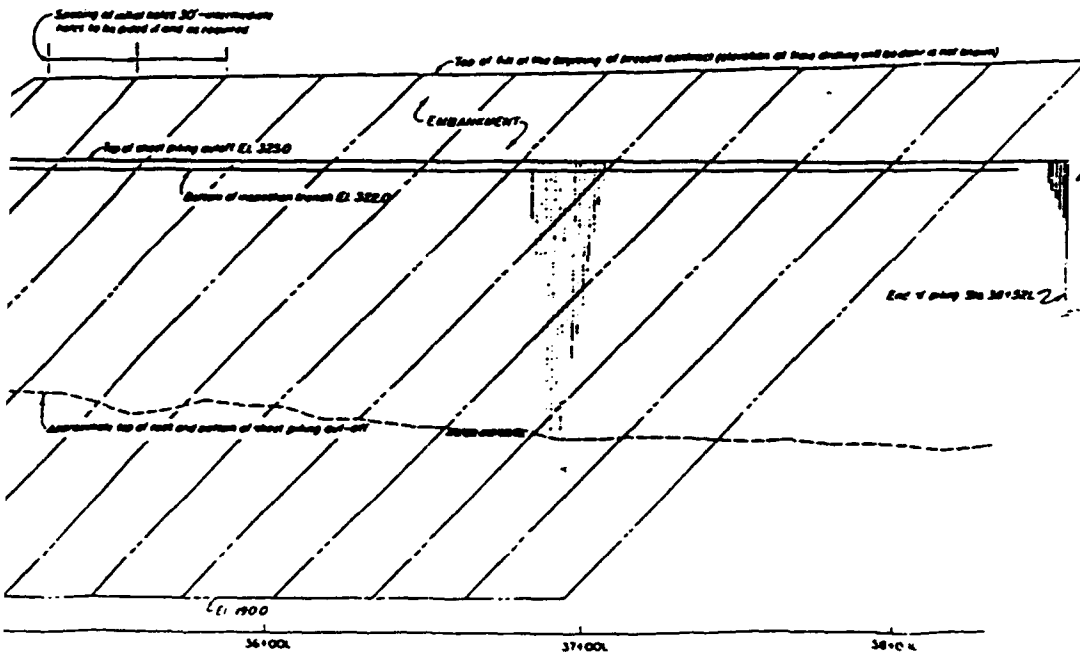
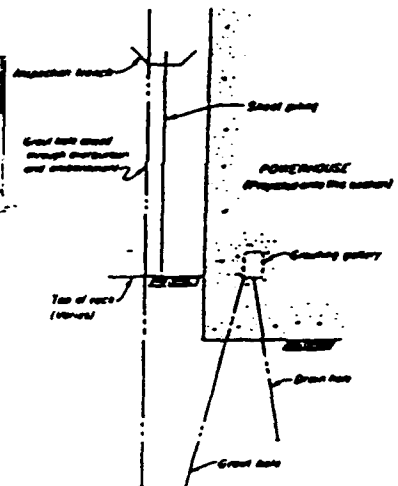
Figure 4. Details of grout curtain and sheetpile wall switchyard section.

grout curtain and sheetpile wall in the
switchyard section.

of the dam. From here the slopes are 1 vertical to 1.75 horizontal to the switchyard which has a surface elevation of 366 feet. The switchyard is 275 feet wide and meets the existing ground at elevation 345 feet with a 1 vertical to 2.5 horizontal slope. An inclined drain, which starts at the centerline at elevation 370 feet and is 9 feet wide (horizontal measurement) was added to control seepage in this area. It has a slope of 1 vertical to 1.5 horizontal and connects to a horizontal drainage blanket. As described previously in Volumes 1 through 4, the alluvial foundation is divided into three units, with Unit 2 being the zone most susceptible to liquefaction. Extensive exploration in this area shows that Unit 1 extends from the surface to elevation 320 feet, Unit 2 from elevation 320 to 305 feet, and Unit 3, which is subdivided into three zones, A, B and C, from elevations 305 feet to the top of rock. Unit 3A is located between elevations 305 and 295 feet and consists of dense sands and gravels interbedded with thin layers of clay. Between elevation 295 and 288 feet is Unit 3B which consists of a soft clay layer that appears to be continuous across the site. This clay layer is interbedded with thin layers of sand. Below elevation 288 feet are denser sands which make up Unit 3C. This part of the embankment is also keyed to the foundation with a trench that is about 23 feet in depth. A sheetpile cutoff was driven through the natural alluvium to rock and a grout curtain was constructed from stations 33+81L to 38+52L. Retaining walls were built upstream and downstream of the powerhouse, parallel to the direction of flow, to protect the embankment dam and its alluvial foundation from erosion. Figures 4 and 5 show sections of the sheetpile cutoff, grout curtain and retaining walls.

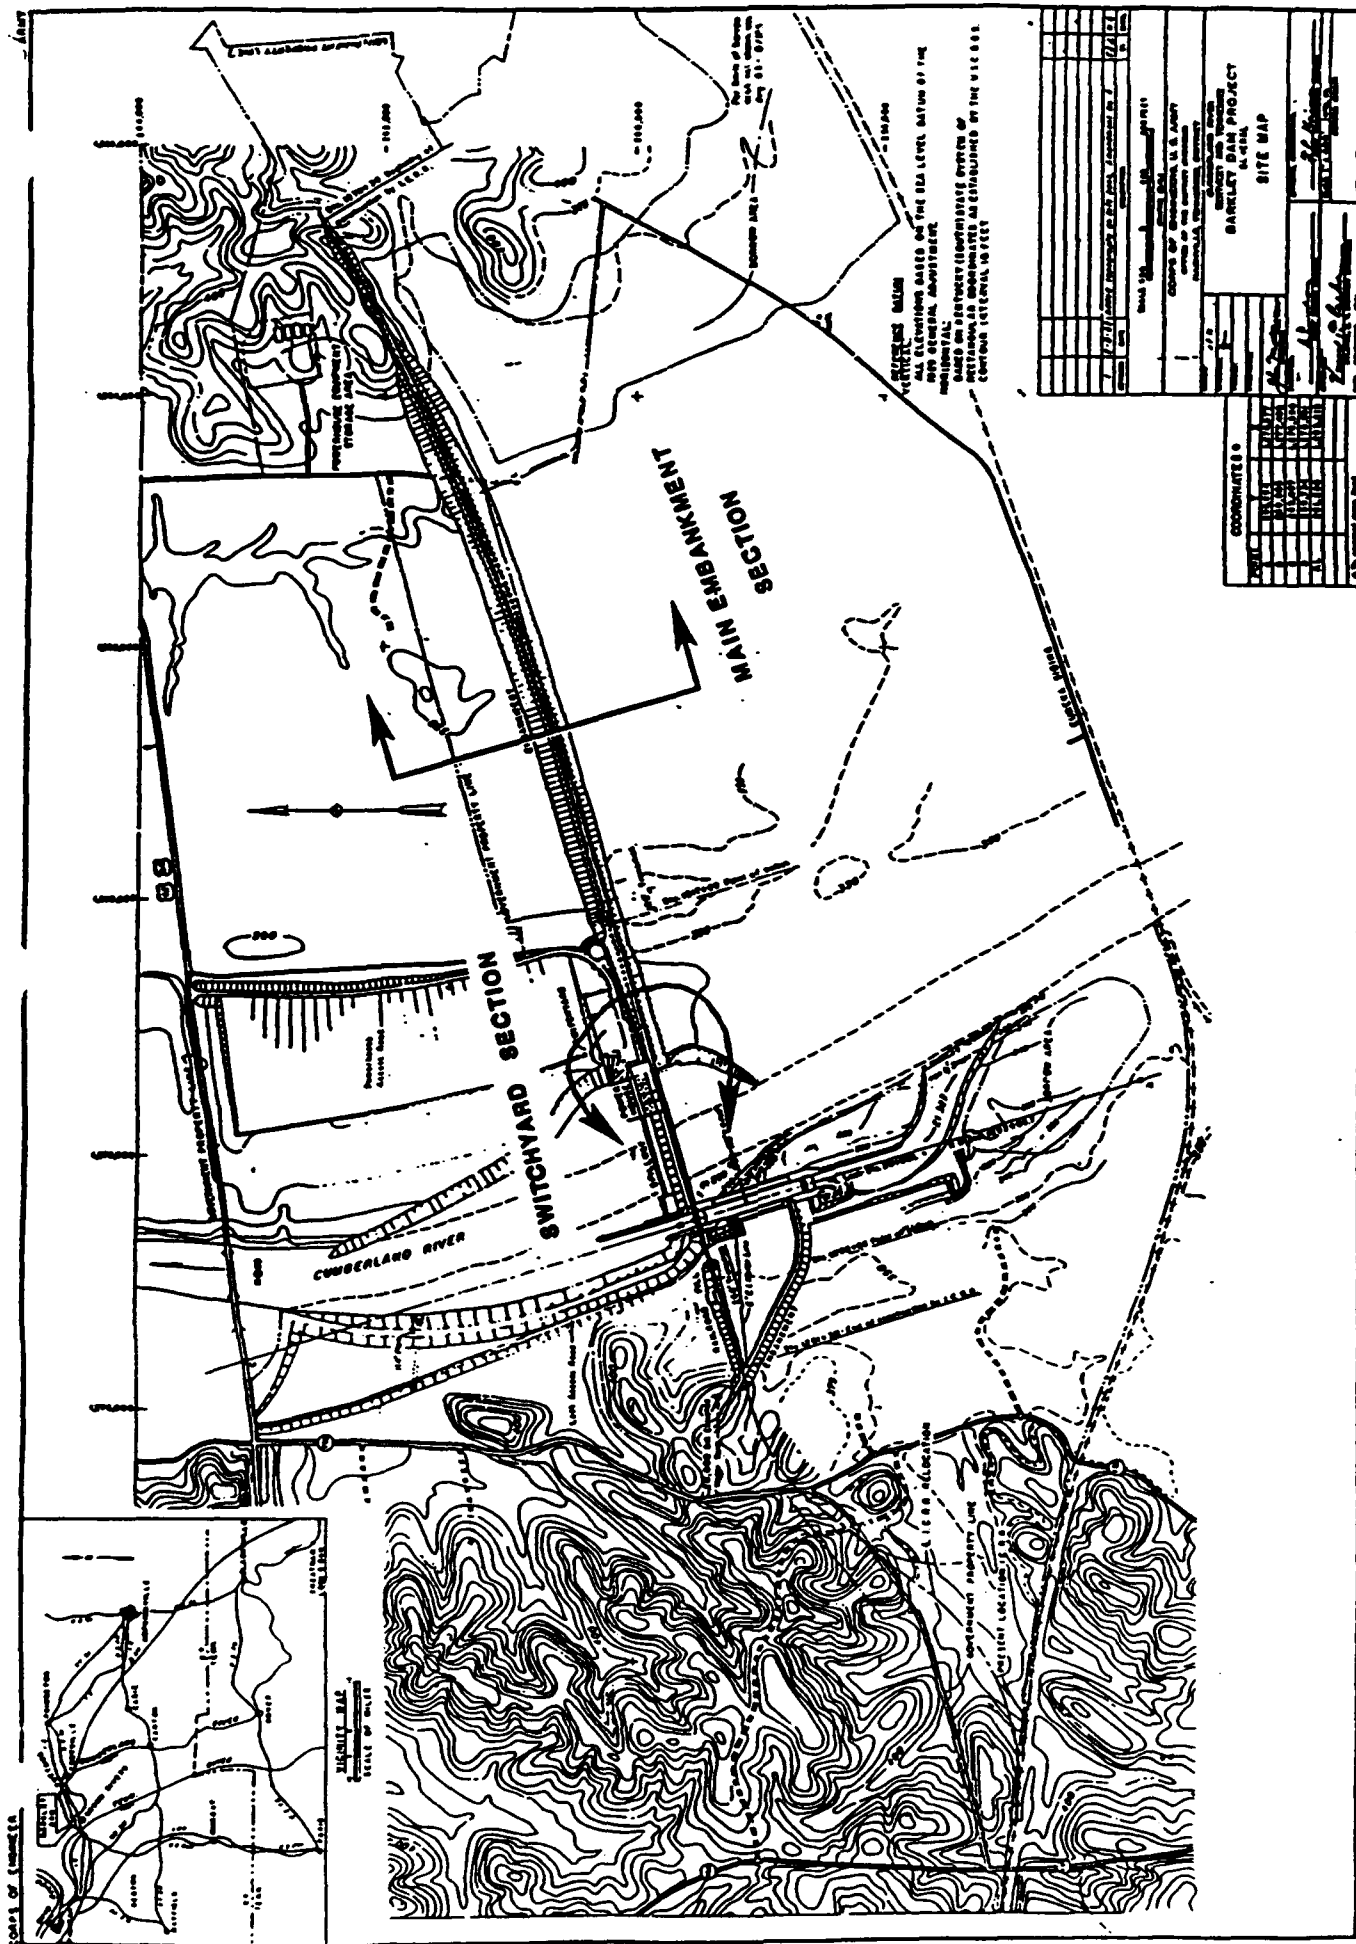
Figure 6. Plan view showing the locations of the analysis sections.

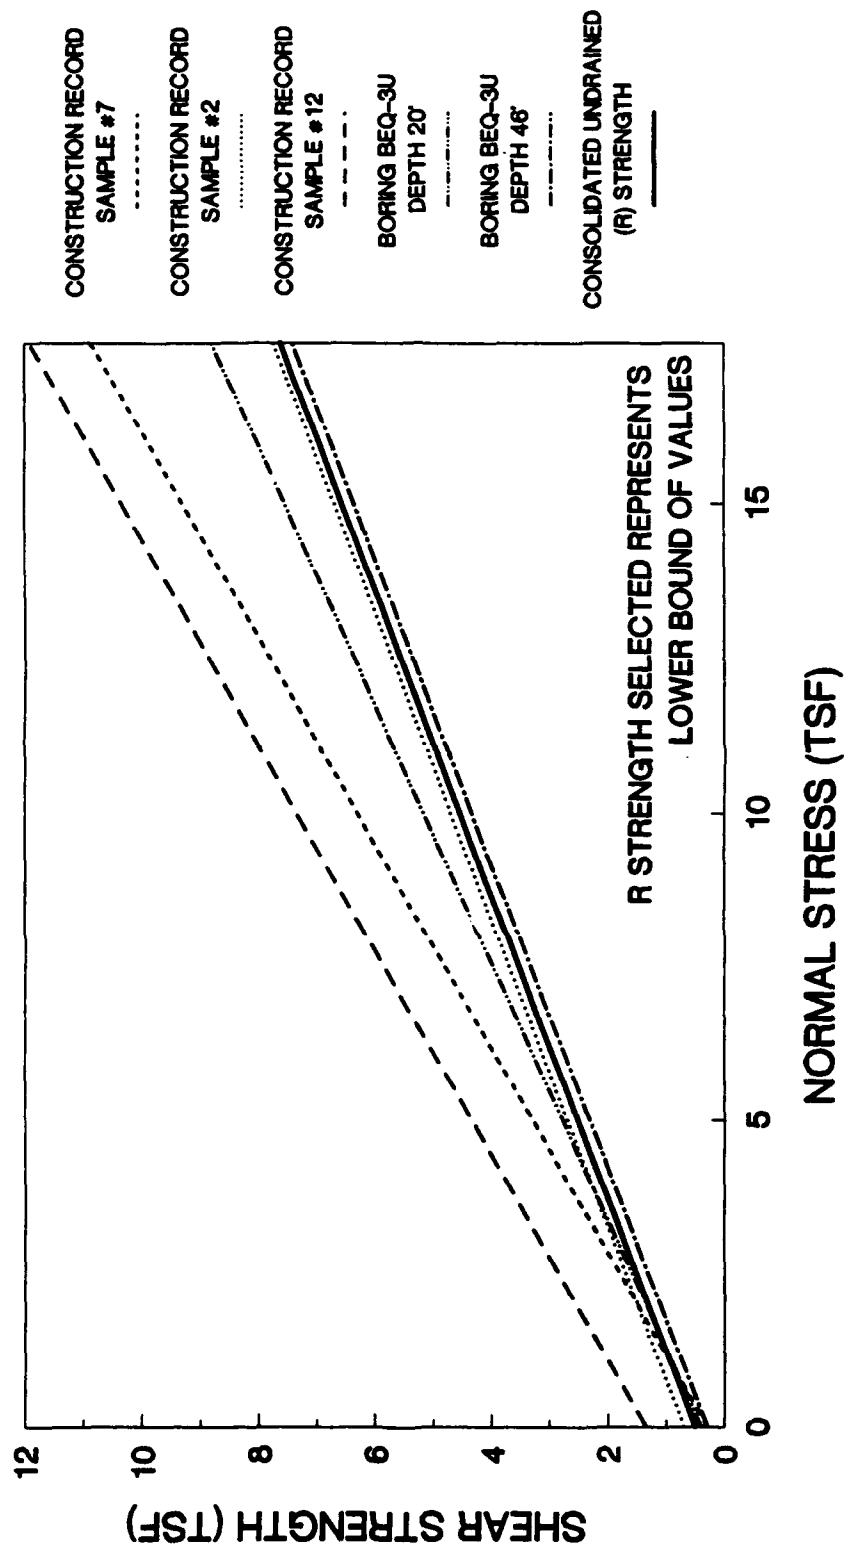
Figure 7. Consolidated - undrained (R) test envelopes for the embankment material.

10. The material properties for the embankment and switchyard were determined from the results of tests reported for construction record samples (Reference 8) and from recent laboratory and in-situ tests performed on samples from borings made for the seismic analysis (see Volume 3). From field densities measured during the construction of the dam, the average moist and saturated unit weights were calculated to be 126 and 128 pounds per cubic foot, respectively. Strength test results were also reported for the samples taken for construction records and performed for samples from recent borings. Figures 7 and 8 show strength envelopes estimated from results of the triaxial tests performed on the embankment materials. The values were selected to represent the embankment strengths prior to the earthquake. Table 1 summarizes these parameters. The shear strength parameters for the random fill represent conservative values as described in the original Design Memorandum 3C.

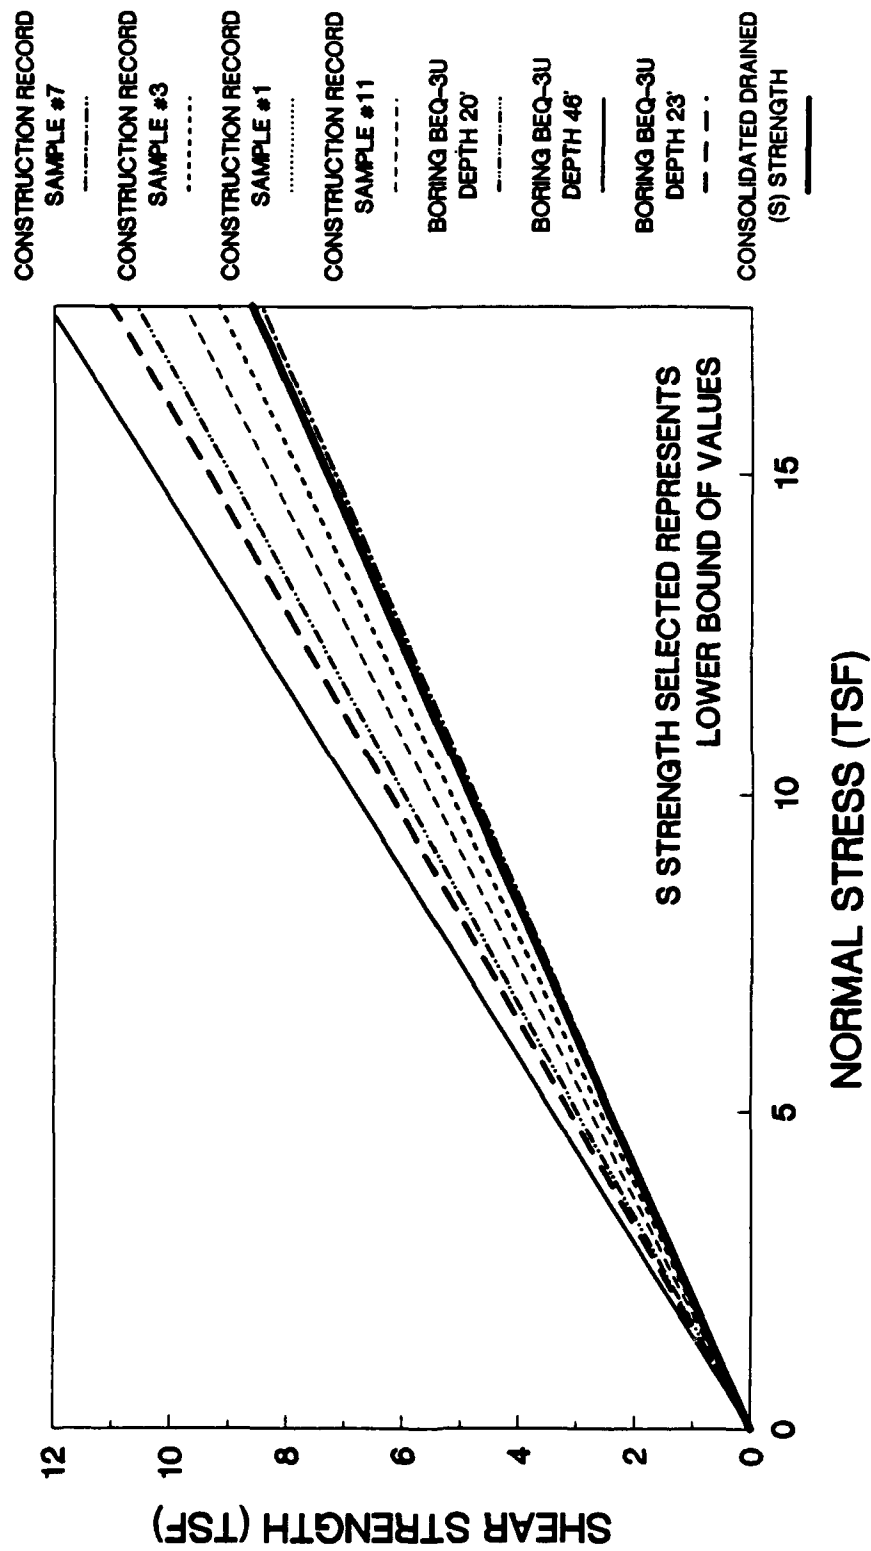
Figure 8. Consolidated - drained (S) test envelopes for the embankment material.

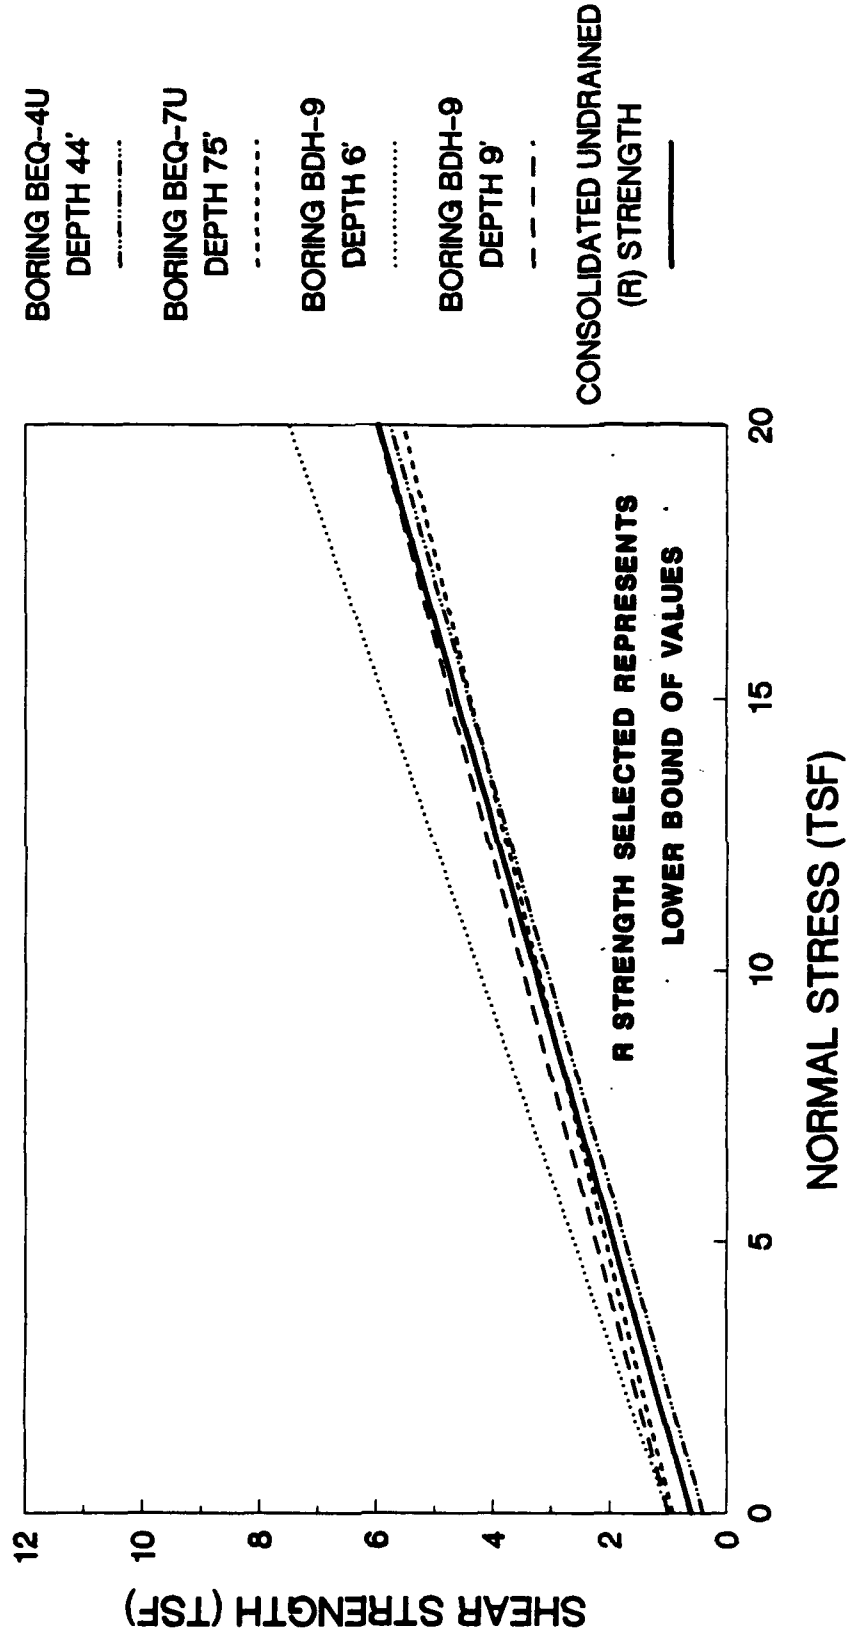
Figure 9. Consolidated - undrained (R) test envelopes for Unit 1 clay material.

from the recent borings made in connection with the seismic analysis. Table 1 summarizes these parameters which represent the estimated strengths prior to the postulated design earthquake. Figures 9 and 10 give the strength envelopes estimated from results of the triaxial tests for Unit 1 (clay) of the foundation. Unit 2, which is dominated by soft clays interbedded with thin layers of sand, is subdivided into these two materials (clay and sand), and the strength of each material is given in Table 1. Figures 11 and 12 give the strength envelopes estimated from the results of the triaxial tests performed on the soft clays and Figure 13 give the strength envelopes estimated from the results of the direct shear tests performed on the sands. No tests were performed on the dense sands and gravels of Units 3A and 3C on the right bank. However, tests were performed on samples taken in this zone on the left bank (Reference 10) and evaluations made in Design Memorandum 3C indicate that these materials were similar to Unit 3A and 3C. Therefore, these strength values were used and no additional tests were made. Tests were not performed on the soft clays in Units 3B and their strengths were assumed to be the same as those of the clays in Unit 2 because the Cone Penetration Test (CPT) values of both units were similar.

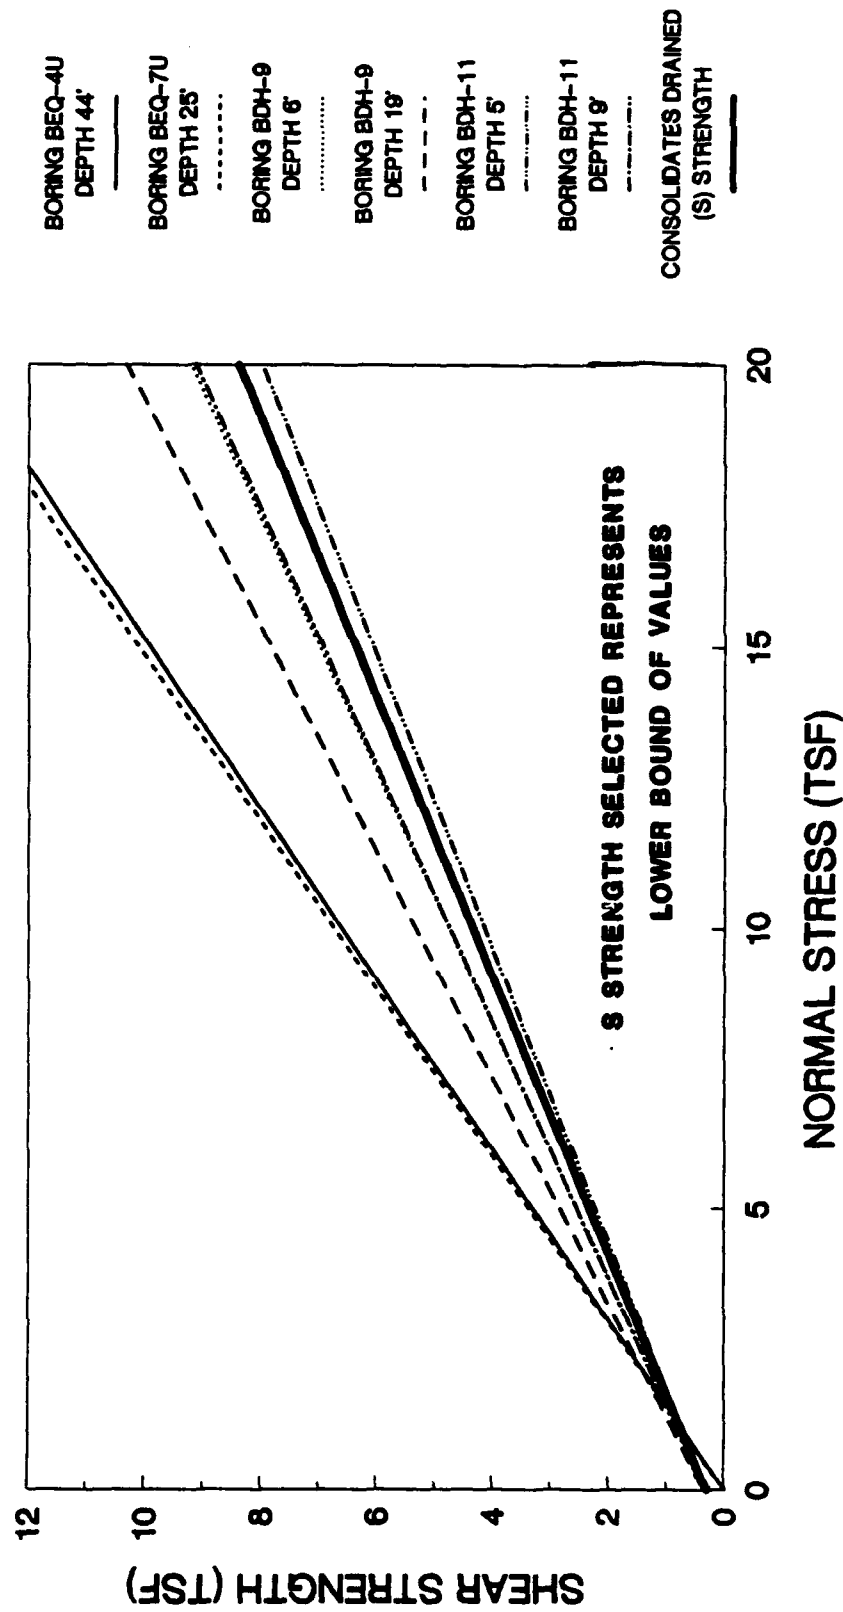
Figure 10. Consolidated - drained (S) test envelopes for Unit 1 clay material.
